MERSEY POINT JETTY

SHOALWATER ROCKINGHAM

ARCHIVAL RECORD

CITY OF ROCKINGHAM

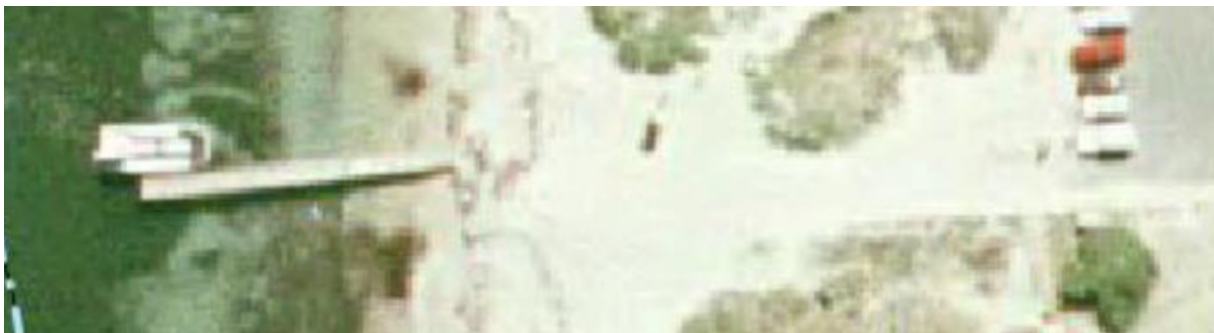
Mersey Point Timber Jetty 1985
Image courtesy of Landgate

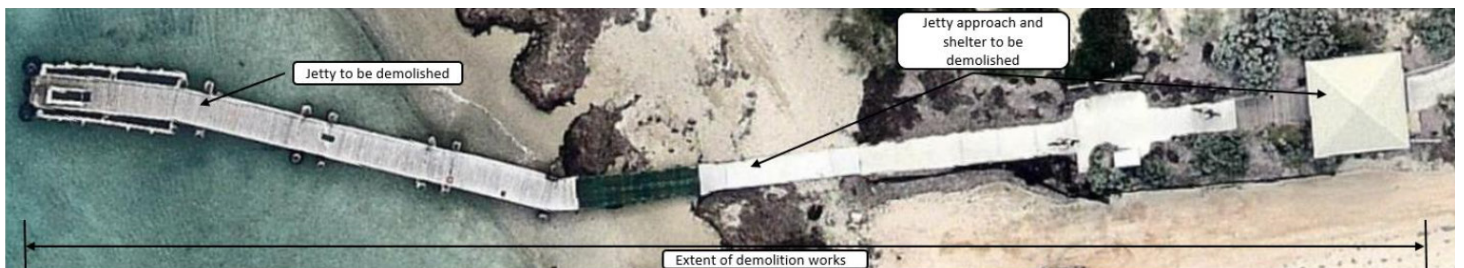
Mersey Point Timber Jetty c2017/18
Image courtesy of Landgate

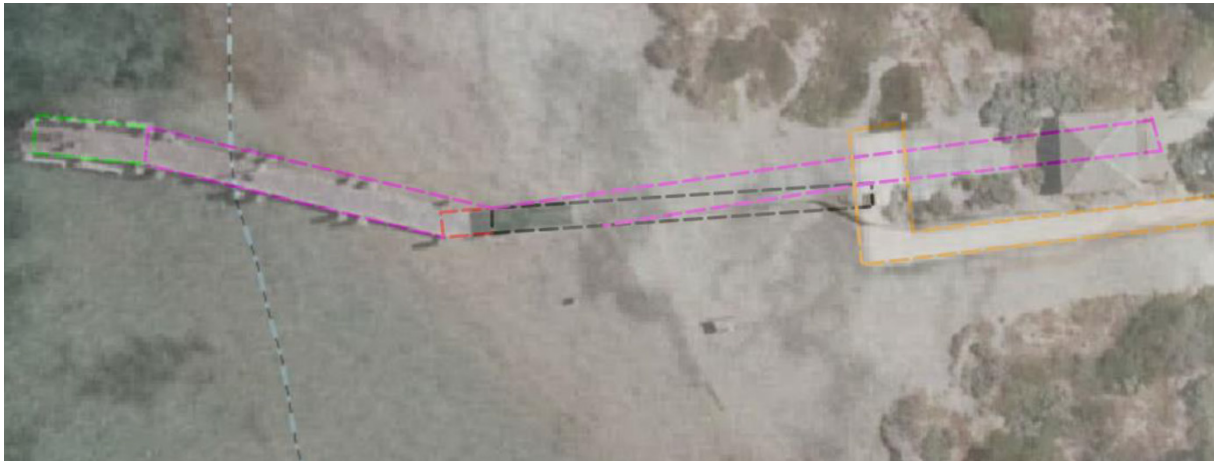
Image Key

Yellow: Includes original timber jetty alignment, commissioned in early 1950s. Minor extensions occurred in 1853. Addition to L section at the end of the jetty was completed in 1965.

Black and Red: Constructed in two separate extensions in 1977 and 79.

Purple: Major works in 1988 included approximately 22m extension, with realignment of jetty approach and shelter installed separately at a later stage.

Green: Between 1995 and 2015 the jetty was extended to its current length. The works included addition bracing to sure-up the jetty, and 2 steel fender piles at the outer edge.

Note: Both the yellow and black sections are no longer visible, and the yellow section is almost certainly no longer in the ground, however, no records on file with the City confirm this.

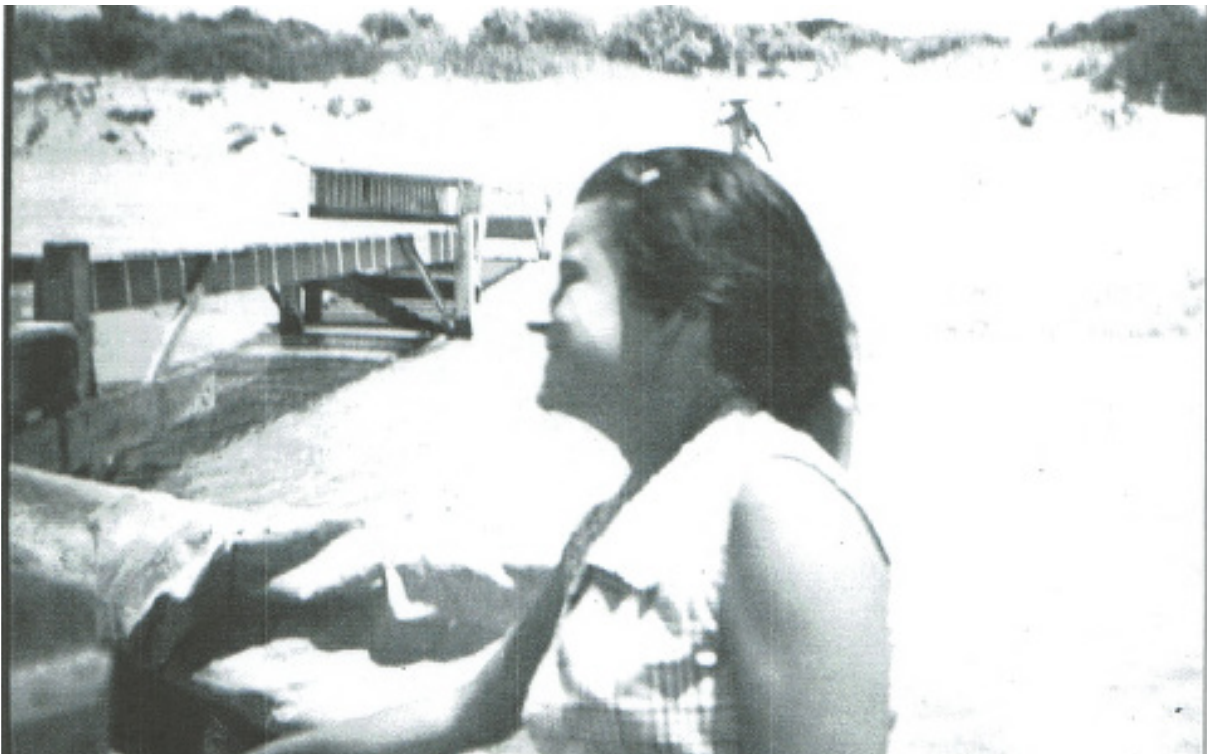
Image of first jetty partially buried and second extension complete at Mersey Point with no jetty in 1953
Source: Elizabeth Foster. July 2009. Photographic History of Mersey Point, Penguin Island, Safety Bay 1920-1965.

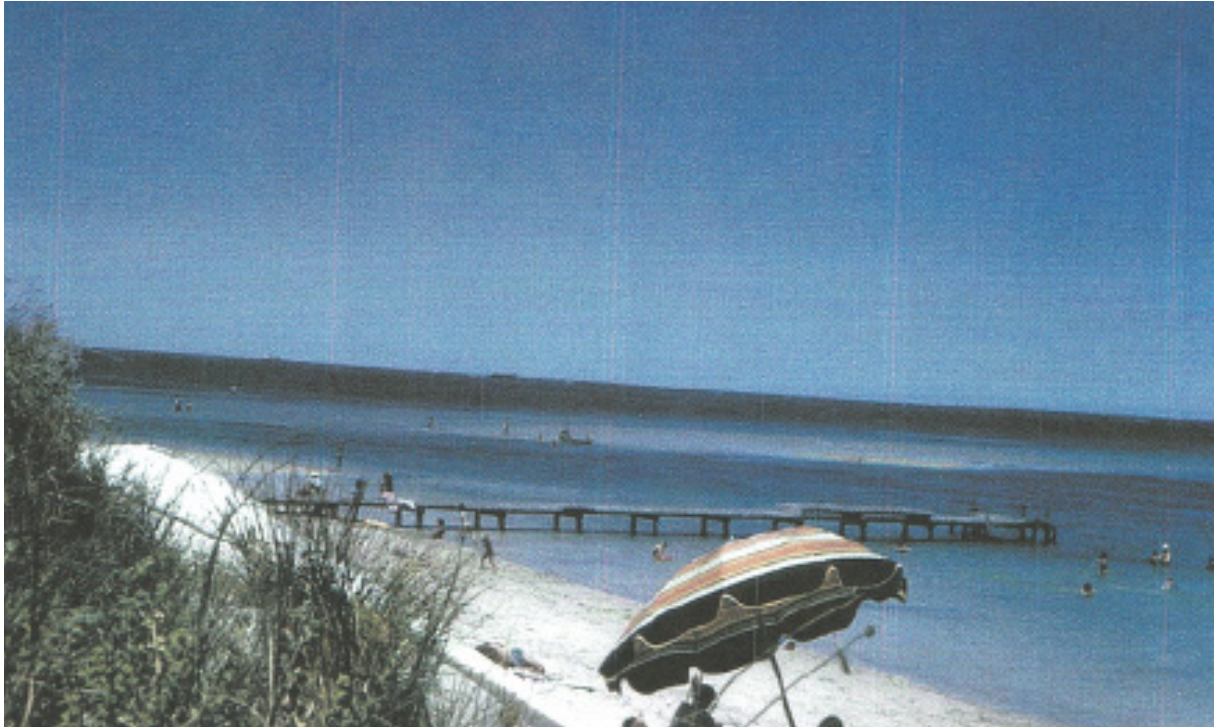
Image of first jetty with second and third extensions complete at Mersey Point with no jetty in 1959
Source: Elizabeth Foster. July 2009. Photographic History of Mersey Point, Penguin Island, Safety Bay 1920-1965.

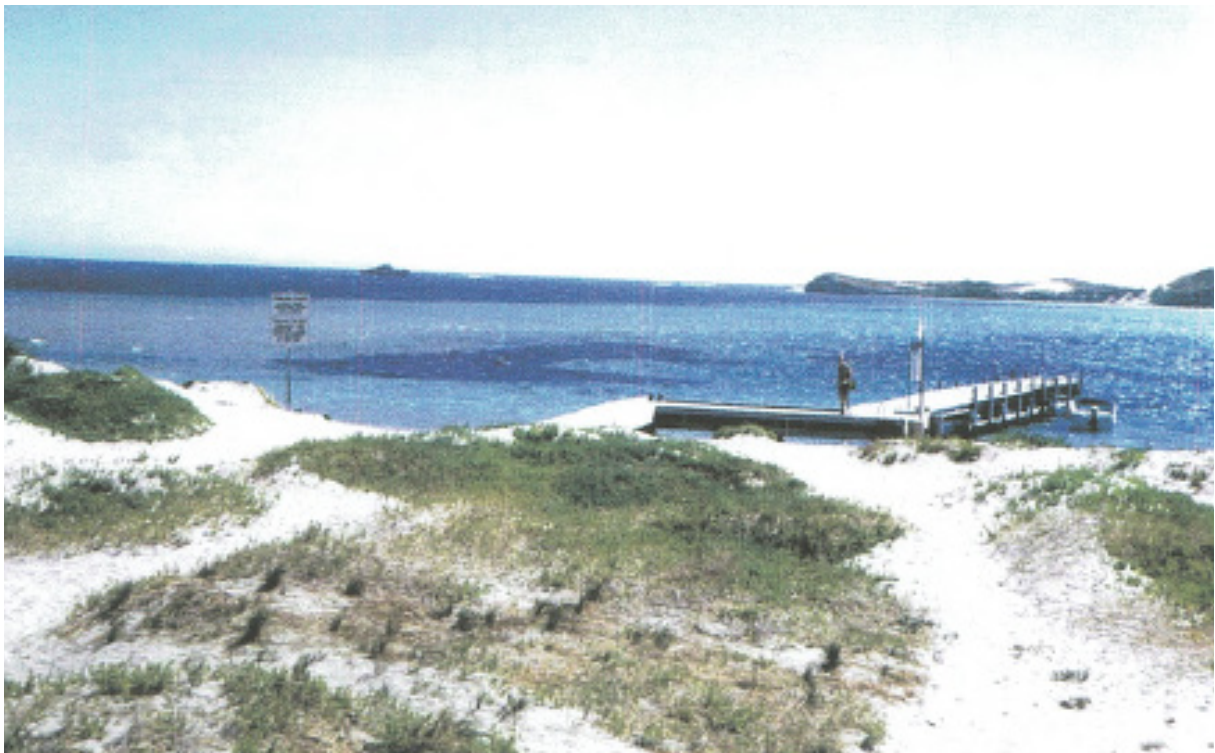
Image of first jetty with fourth and fifth extensions complete at Mersey Point with no jetty in 1965
Source: Elizabeth Foster. July 2009. Photographic History of Mersey Point, Penguin Island, Safety Bay 1920-1965.

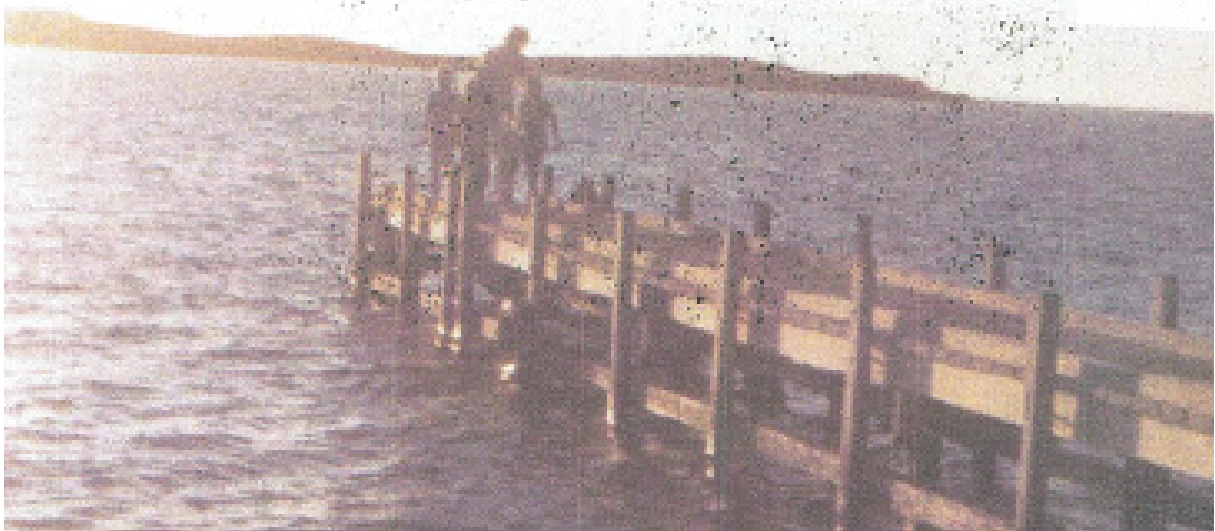
Image of jetty with fifth extension at Mersey Point 1977

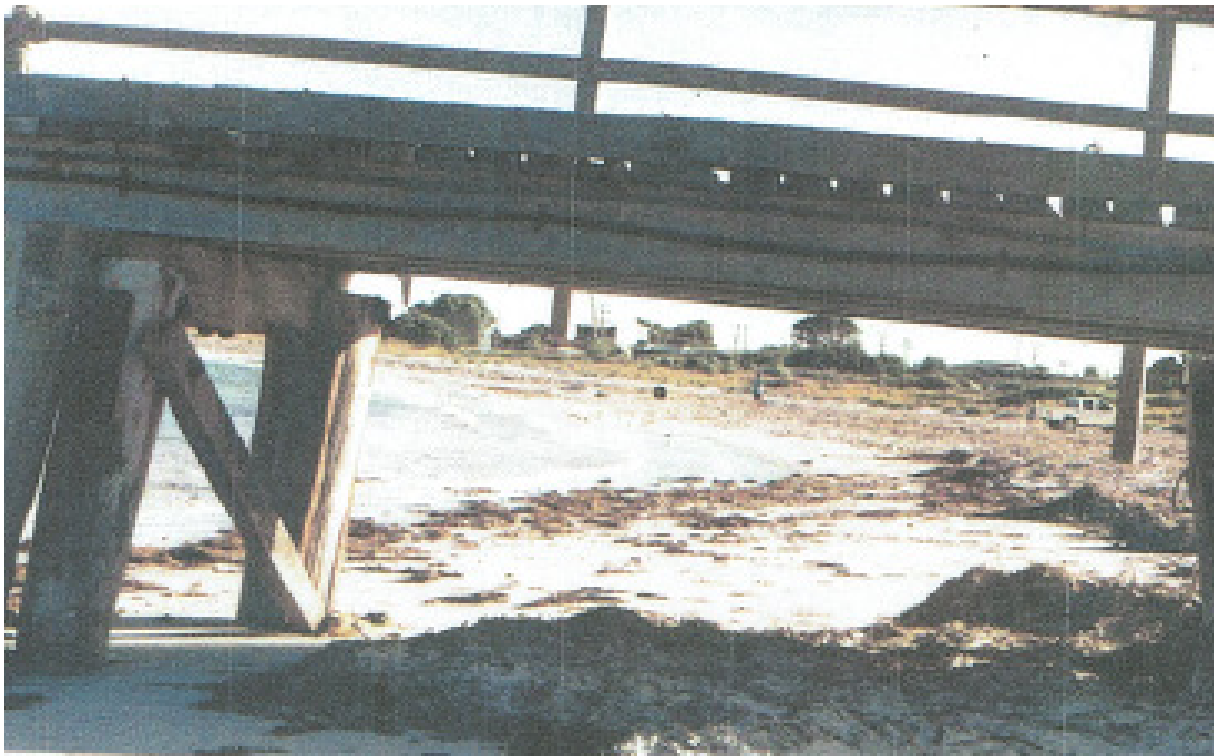
Image of jetty now completely buried in sand 1979

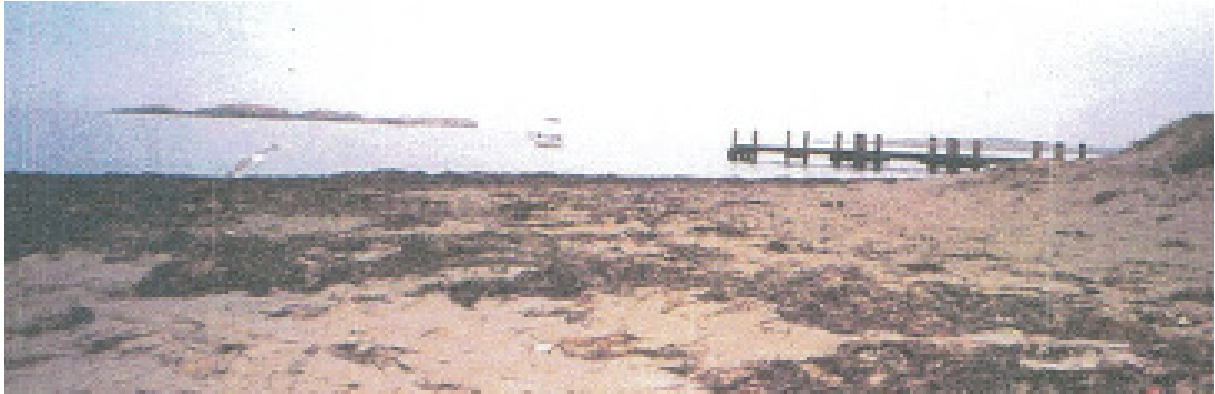
Image of jetty with sixth extension at Mersey Point (date unknown)
Source: Elizabeth Foster. July 2009. Photographic History of Mersey Point, Penguin Island, Safety Bay 1920-1965.

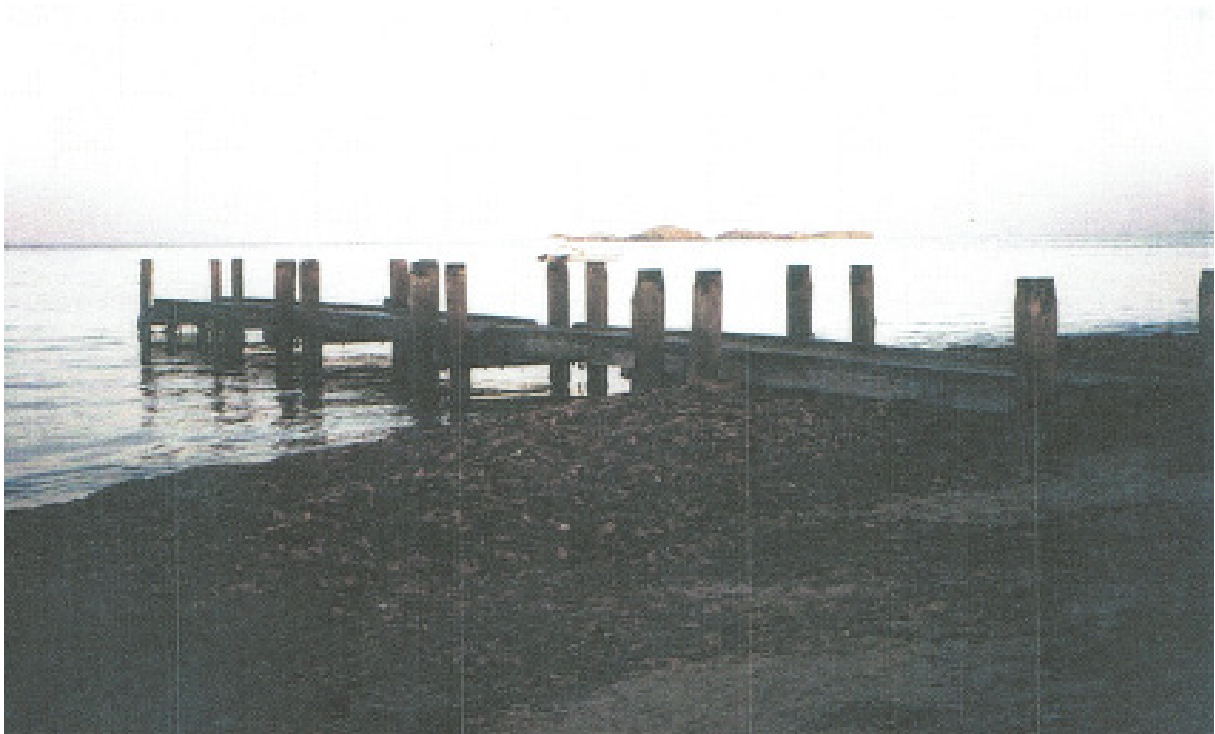
Image of jetty with sixth extension at Mersey Point (date unknown)
Source: Elizabeth Foster. July 2009. Photographic History of Mersey Point, Penguin Island, Safety Bay 1920-1965.

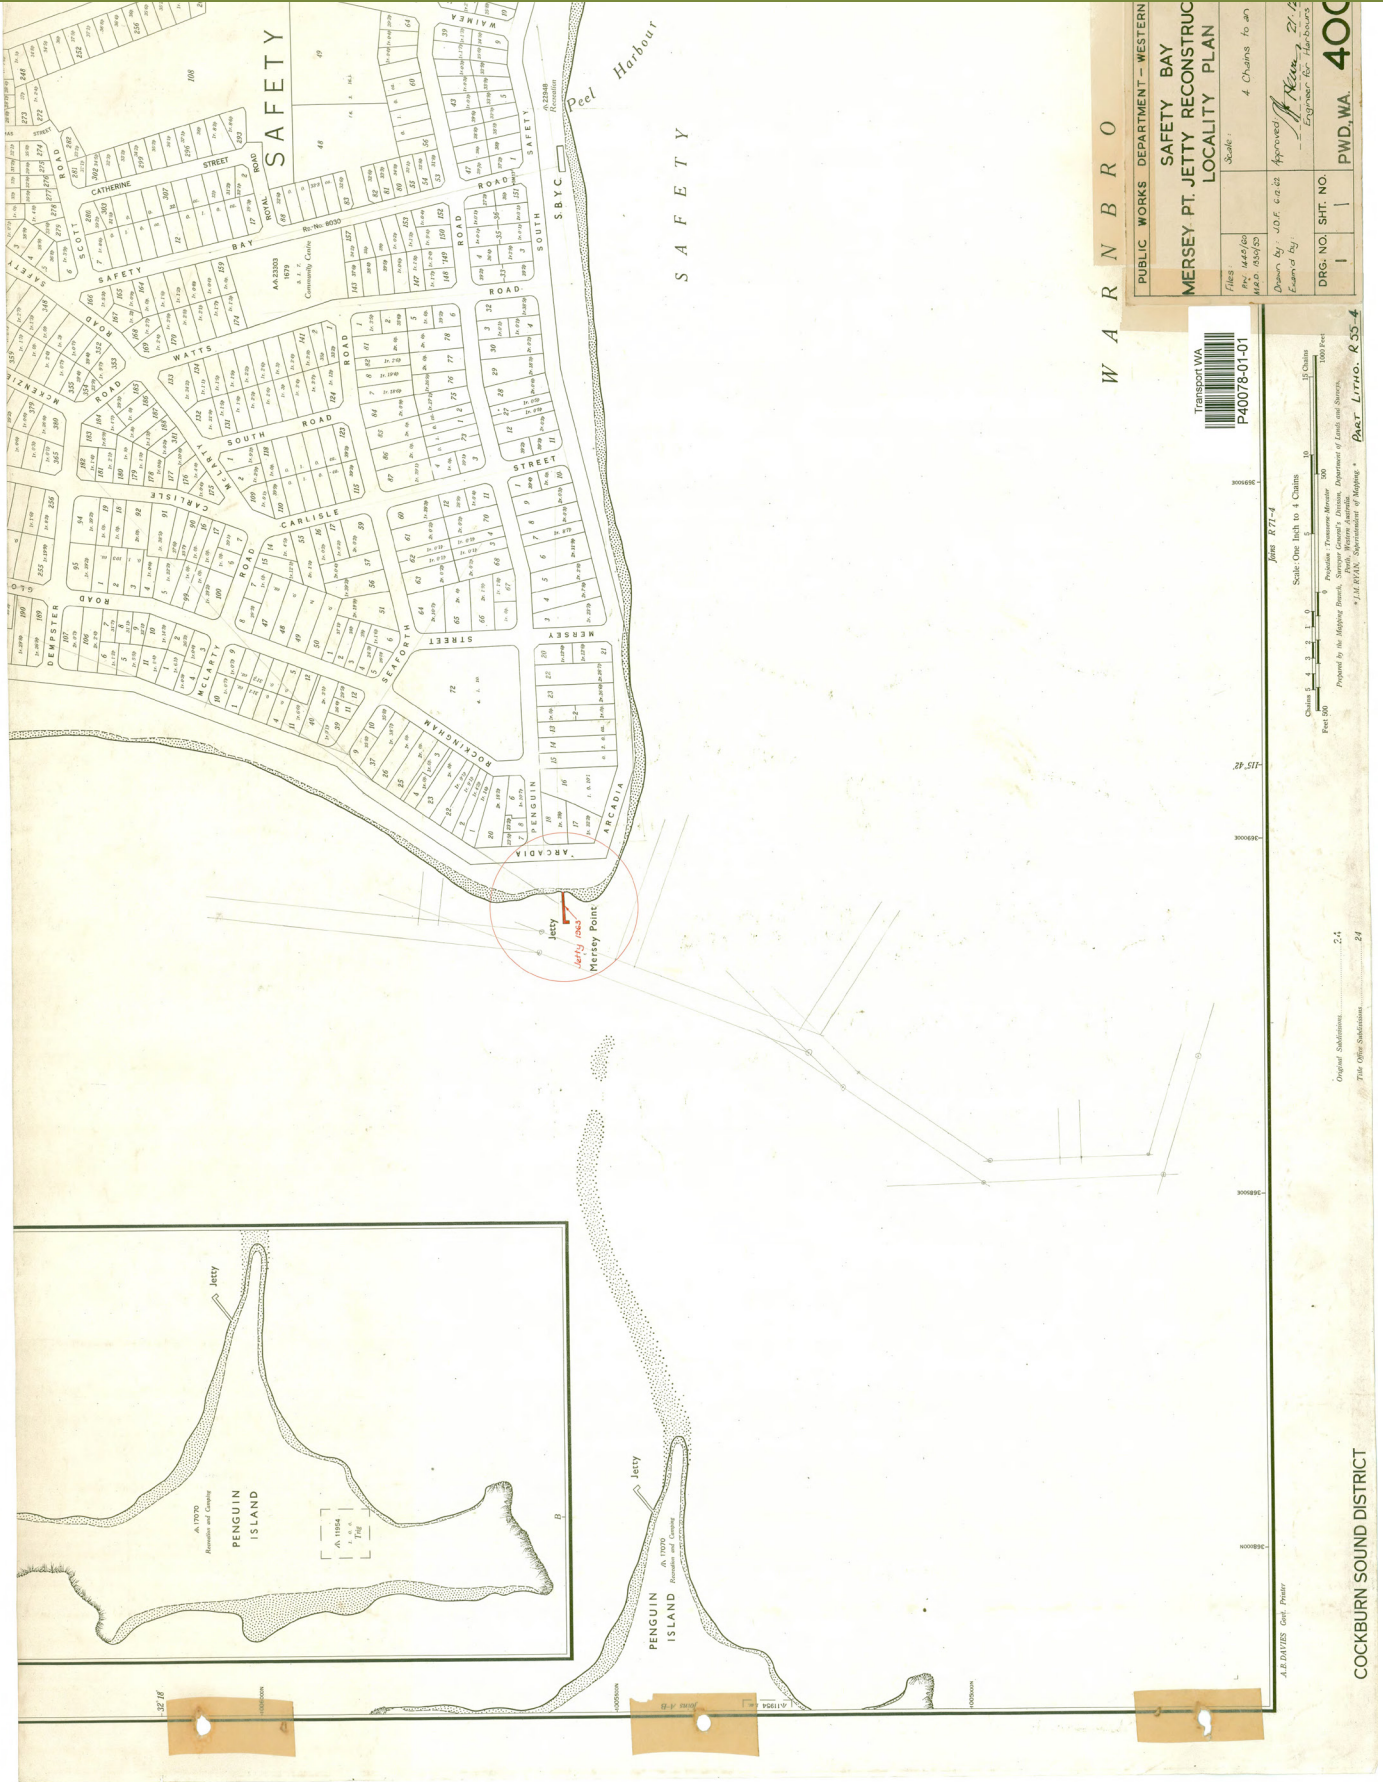
Source: Mersey Point Jetty Reconstruction Drawings- 1962, Western Australian Public Works Department cited in MP Rogers & Associates Pty Ltd (MRA) 2014. Mersey Point Jetty Condition Inspection. Prepared for the City of Rockingham.
